# MAIDSTONE CENTRE CONSERVATION AREA Character Appraisal & Management Plan

**Maidstone Borough Council**

*Draft, August 2020*

# MAIDSTONE CENTRE CONSERVATION AREA APPRAISAL

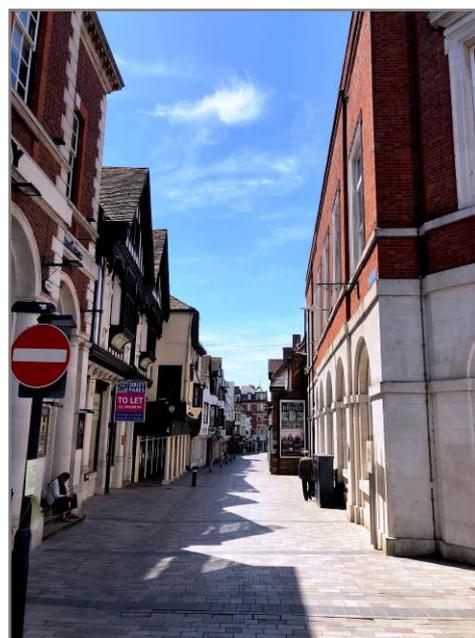
Maidstone Town Centre is highly urban in character and the streets have strongly defined edges.

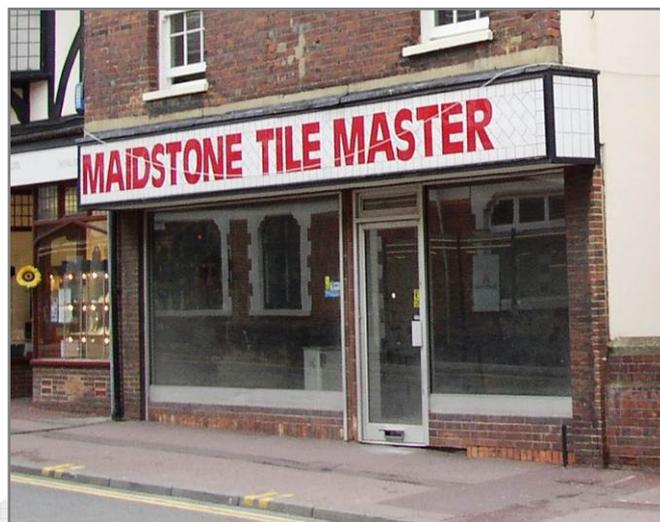
Poor quality shopfronts detract from the character of the Conservation Area in some places.

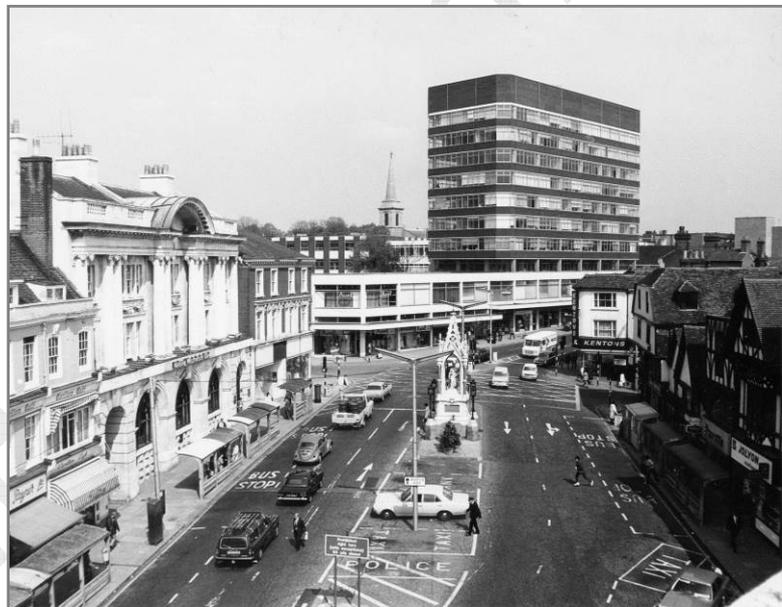
Colman House forms an unfortunate focal point at the top of the High Street (1970s photo).

Colman House also forms an unfortunate focal point in views up High Street and Bank Street, competing unfortunately with the spire of Holy Trinity Church which would otherwise perform this function much more satisfactorily.

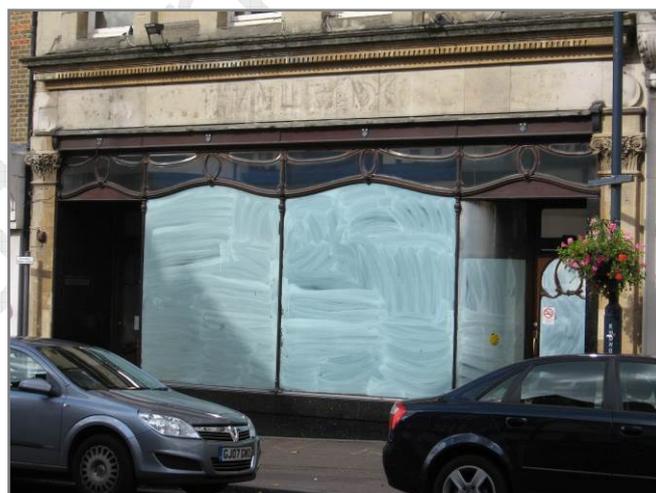
Historic shopfronts should be preserved
